**ASSESSMENT AND PRIORITIZATION OF  
STREAMS IN UPPER POCOMOKE, WESTERN  
BRANCH, PISCATAWAY CREEK, OXON CREEK,  
PATUXENT RIVER MIDDLE, AND BALTIMORE  
HARBOR WATERSHEDS IN NEED OF  
RESTORATION AND PROTECTION**

**Final Data Report:**

**Assessment and Prioritization of Streams in the Upper Pocomoke, Western Branch,  
Piscataway Creek, Oxon Creek, Patuxent River Middle, and Baltimore Harbor Watersheds  
in Need of Restoration and Protection**

**Scott Stranko,  
Jay Kilian  
and  
Martin Hurd**

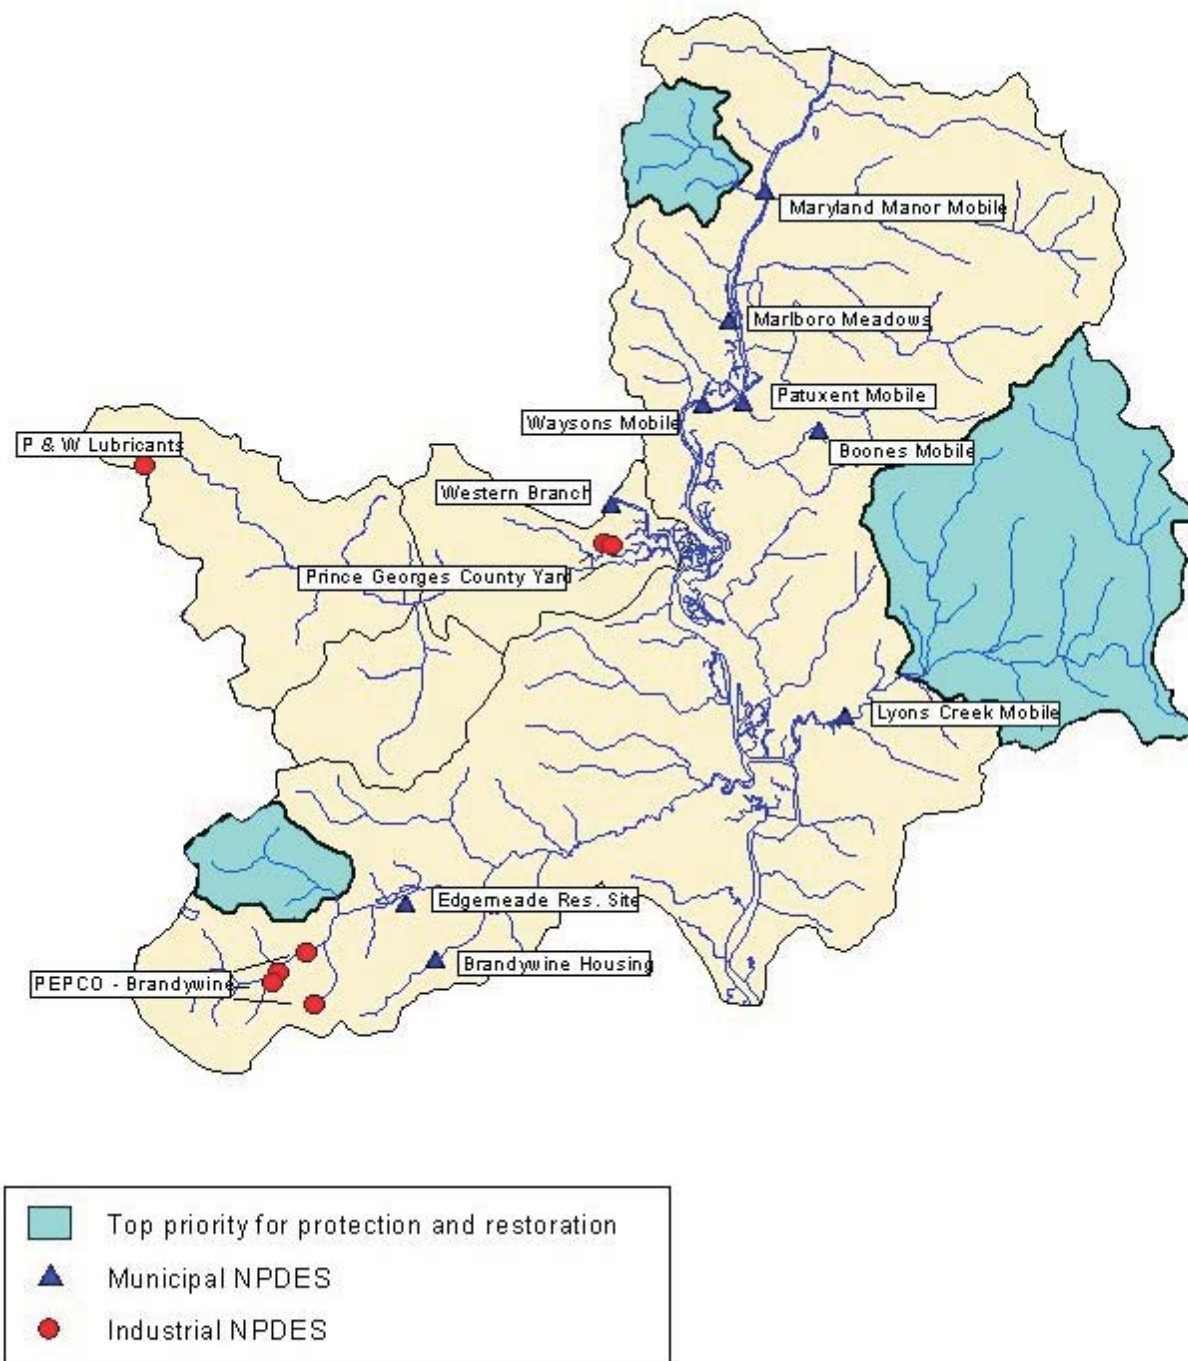
Figure 15. Municipal and Industrial NPDES sites in the Patuxent River Middle watershed.

A large number (16) industrial and municipal NPDES permits have been issued in the Patuxent River Middle watershed. None of them, however, are located in catchments that are recommended as top priority for protection and restoration. (Figure 15 ).
